II. Work in Progress

Phoenix Project

WEDGE 1

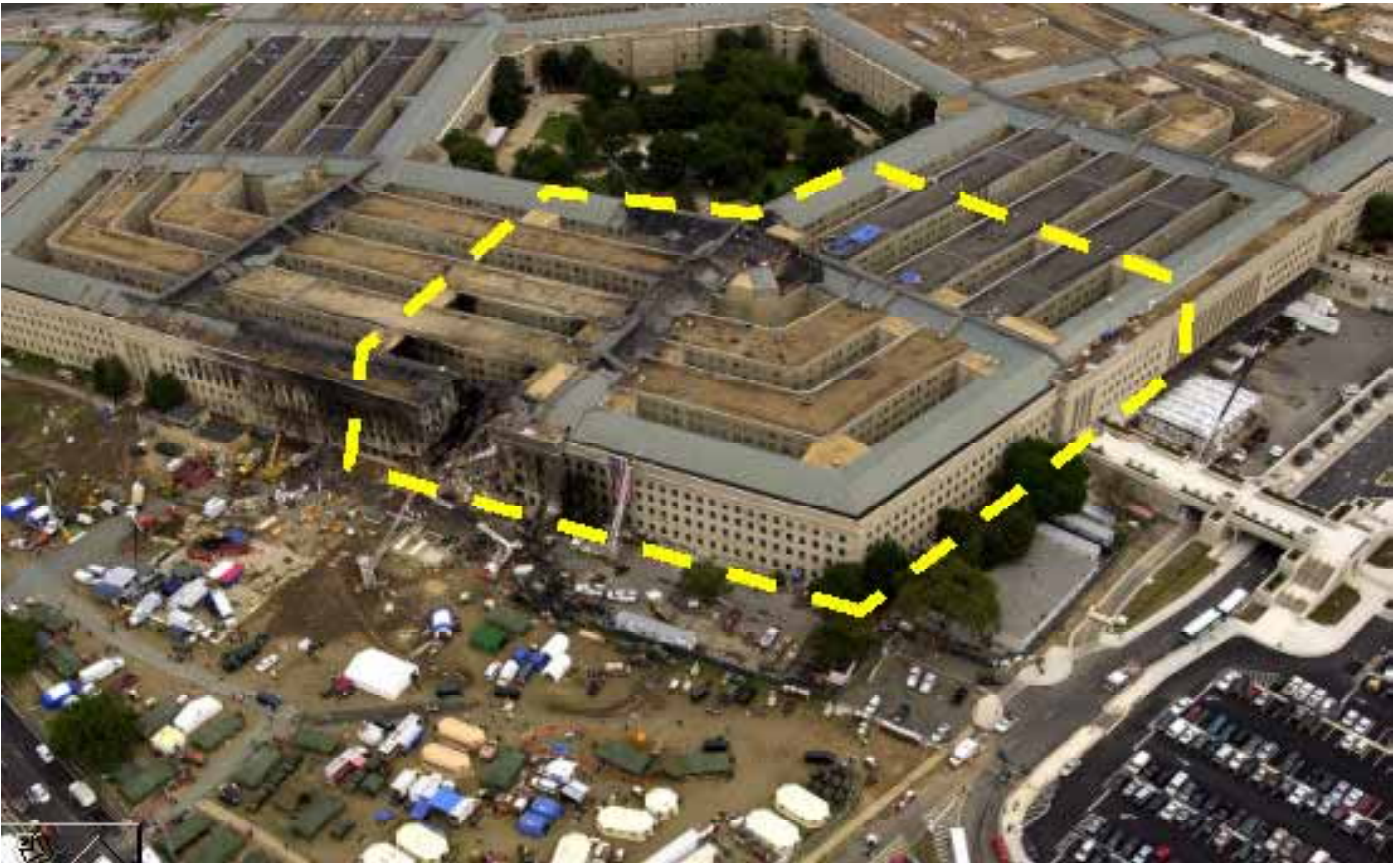
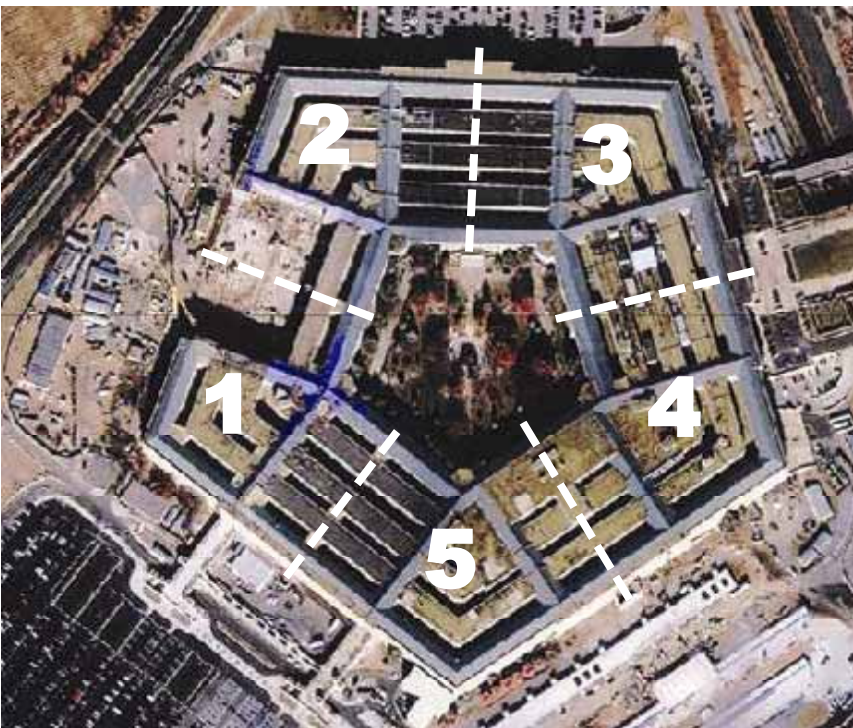
The photo above outlines Wedge 1. Nearly all of the one million square feet of space suffered damage to varying degrees. The photo to the left was shot on November 20, 2001, the day after demolition was complete on the Phoenix Project. When core and shell work on the Phoenix Project is complete, tenant fit-out construction will be accomplished in conjunction with the remainder of the Wedge1 rebuild effort.

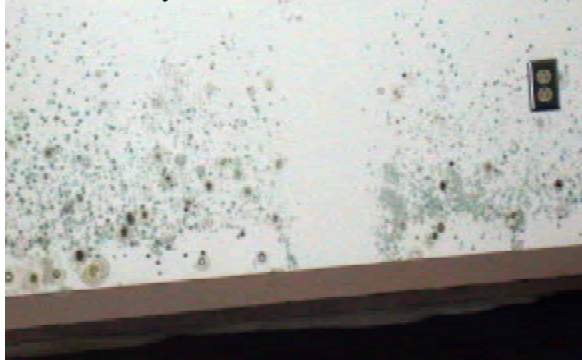
Then & Now

The photos on the left depict the damage done to various areas of Wedge 1 as a result of the 9/11 attack.

Many areas not in the direct path of Flight 77 suffered water damage from the newly installed sprinkler system. Debris and smoke damage from the ensuing explosion affected other areas like the new cafeteria.
